Manhole Inspection Summary

Manhole # S25G__004MH

Insp Date: **8/31/07 10:53 AM**

Location Address: **106 CARLTON ST**

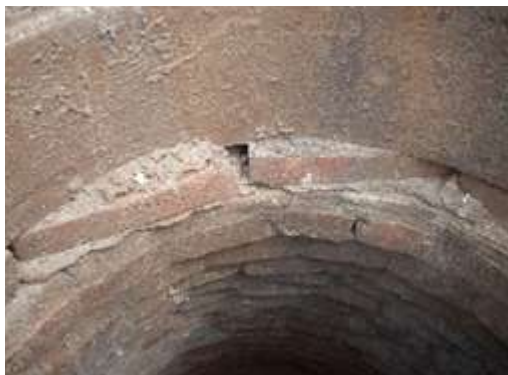
Defect 4

Condition: ☐ Sound ☐ Cracked ☐ Root Intrusion ☐ Loose Brick ☒ **Deteriorated**

DETERIORATED CHIMNEY

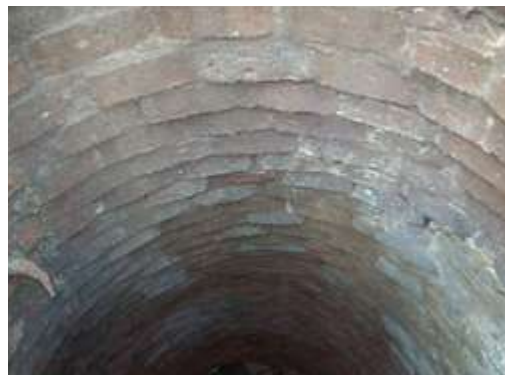
Defect 3

Infiltration: ☐ None ☐ Joint ☐ Cracks ☐ Mortar ☐ Roots ☒ **Wall**

INFILTRATION OF BARREL AND CORBEL WALL

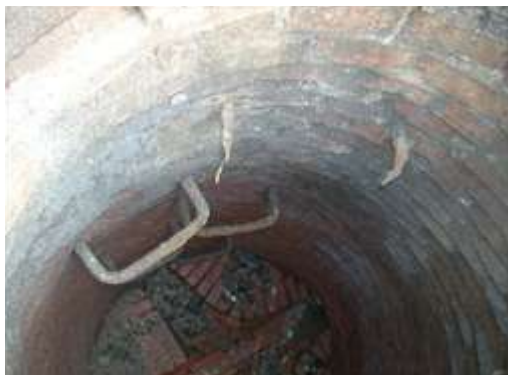
Defect 2

Count: **4** Missing: **1** ☒ **Corroded**

CORRODED AND MISSING STEPS

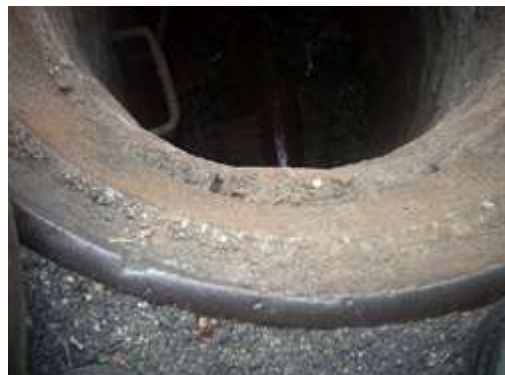
Defect 1

Offset: **1** (in.)

FRAME OFFSET

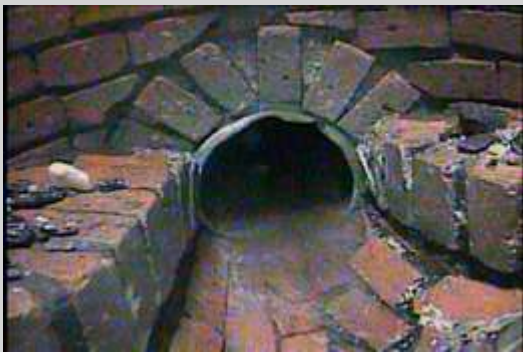
12 O'Clock Outflow

Pipe Height: **8.4** (in.) Rod and Bar (Angled)
Pipe Material: **Clay** ☐ Pipe Lined
Invert Depth: **9.51** (ft.) Flow Characteristics: **Slow**
Deposits: ☒ None ☐ Mud ☐ Sludge ☐ Debris ☐ Grease
Silt Depth: (in.) Deposits Extent:
Infiltration: **None** Pipe Seal Cond: **Sound**

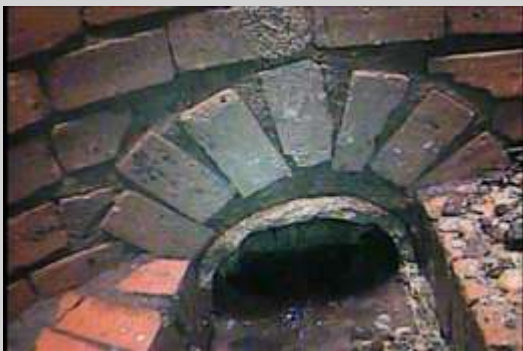
3 O'Clock Inflow

Pipe Height: **7.2** (in.) Rod and Bar (Angled)
Pipe Material: **Clay** ☐ Pipe Lined
Invert Depth: **7.43** (ft.) Flow Characteristics: **Slow**
Deposits: ☒ None ☐ Mud ☐ Sludge ☐ Debris ☐ Grease
Silt Depth: (in.) Deposits Extent:
Infiltration: **None** Pipe Seal Cond: **Sound**

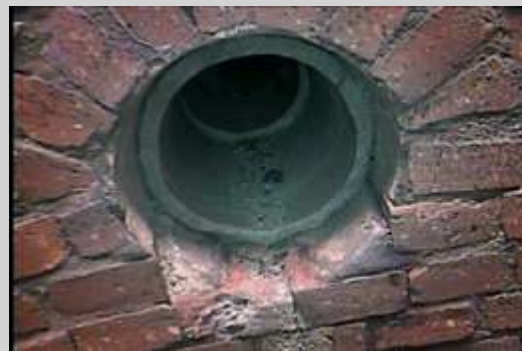
Drop In @ 3 O'Clock

Drop: **Outside** Rod and Bar
Angled: **Yes** Reading: **8.24** (ft.)
Inv Depth: **9.24** (ft.)
Drop Condition: **Open**

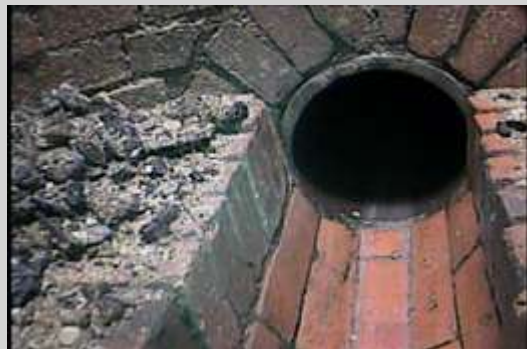
6 O'Clock Inflow

Pipe Height: **8.4** (in.) Rod and Bar (Angled)

Infiltration: **None** Pipe Seal Cond: **Sound**
